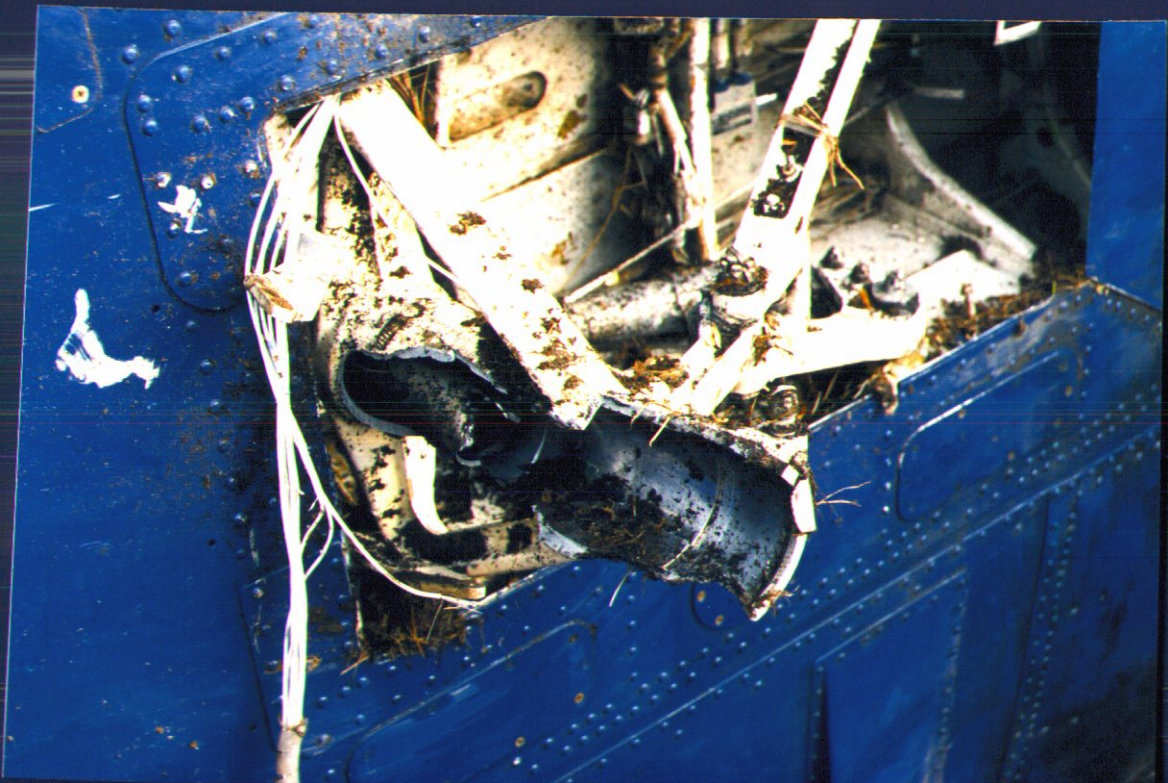
Photo 14: View of left main landing gear upper housing still attached to the left wing.
